# **REPORT OF UNOMIG ON THE INCIDENT OF 20 APRIL INVOLVING THE DOWNING OF A GEORGIAN UNMANNED AERIAL VEHICLE OVER THE ZONE OF CONFLICT**

## **Introduction**

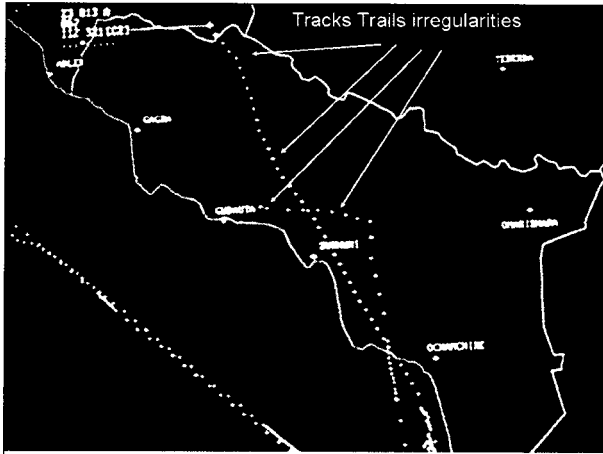
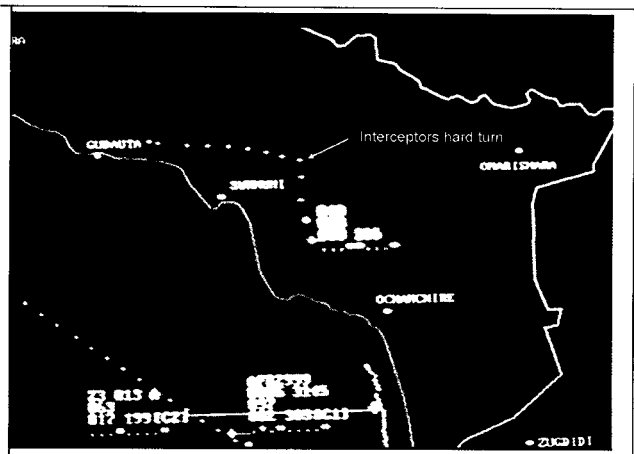
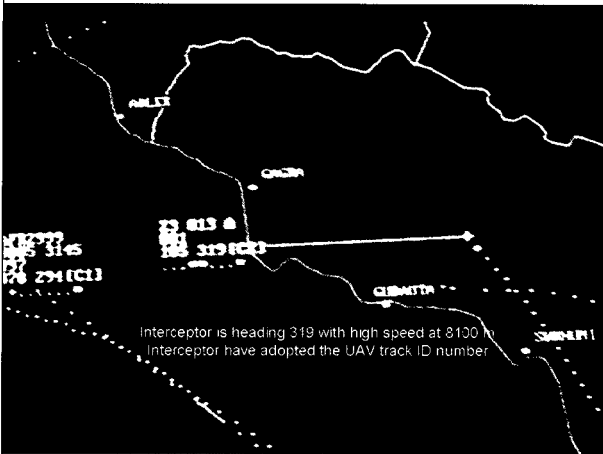
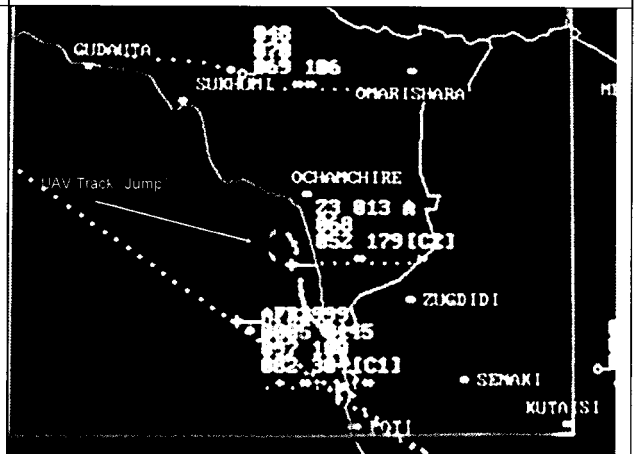
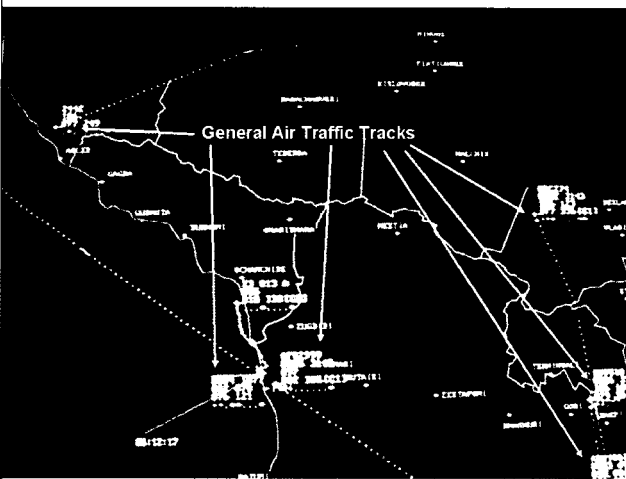
Radar track images

21. The tracks trails of both the UAV and the interceptor are not completely straight, but they have small deviations or curves. The General Air Traffic (GAT) does not have these deviations from a straight track because commercial aircraft are flying with the autopilot engaged. (See annex). If the radar record had been created by a simulator, those kind of small deviations would not have been expected, because simulators normally only create straight tracks.

22. The track turns of the UAV and the interceptor are imperfect but look normal for real aircraft and not as simulated tracks. Especially for the UAV, it can be seen that when the UAV makes a sharp turn to the left, heading south, in order to avoid the interceptor, the radar loses contact for a while and after that it finds it again, resulting in a small 'jump' in the track.

23. Furthermore, the interceptor, after its take off, follows an easterly course and performs a sharp turn that in the radar video looks very steep. This kind of turn would not be expected from simulated tracks, because these normally follow circular courses. These kinds of turn can be seen in several places in the radar record, but the two described above are the most representative and obvious examples of non-simulated track movement.

24. In all the tracks of the GAT, UAV and interceptor, the altitude and the ground speed is not steady but changing all the time as the radar computer is recalculating all the flight data continuously. Simulated tracks are expected to have steady indications, or smooth changes between two steady values. For instance, if a simulated track should show an aircraft changing altitude from 080 to 110, one should expect a smooth change like the following: 080, 080, 080, 092, 098, 103, 107, 110, 110, 110. The same applies for the speed. However, this is not the case on this radar record.

25. From the radar record it can be seen that, when the interceptor is heading back north after having shot down the UAV, the interceptor has adopted the track number of the UAV. This track label swap is a common computer mistake that may occur when two tracks are very close to each other and then merged. This kind of deliberately created mistake never occurs on simulated tracks.
